STS-105

FLIGHT READINESS REVIEW

August 1, 2001

Ground Operations

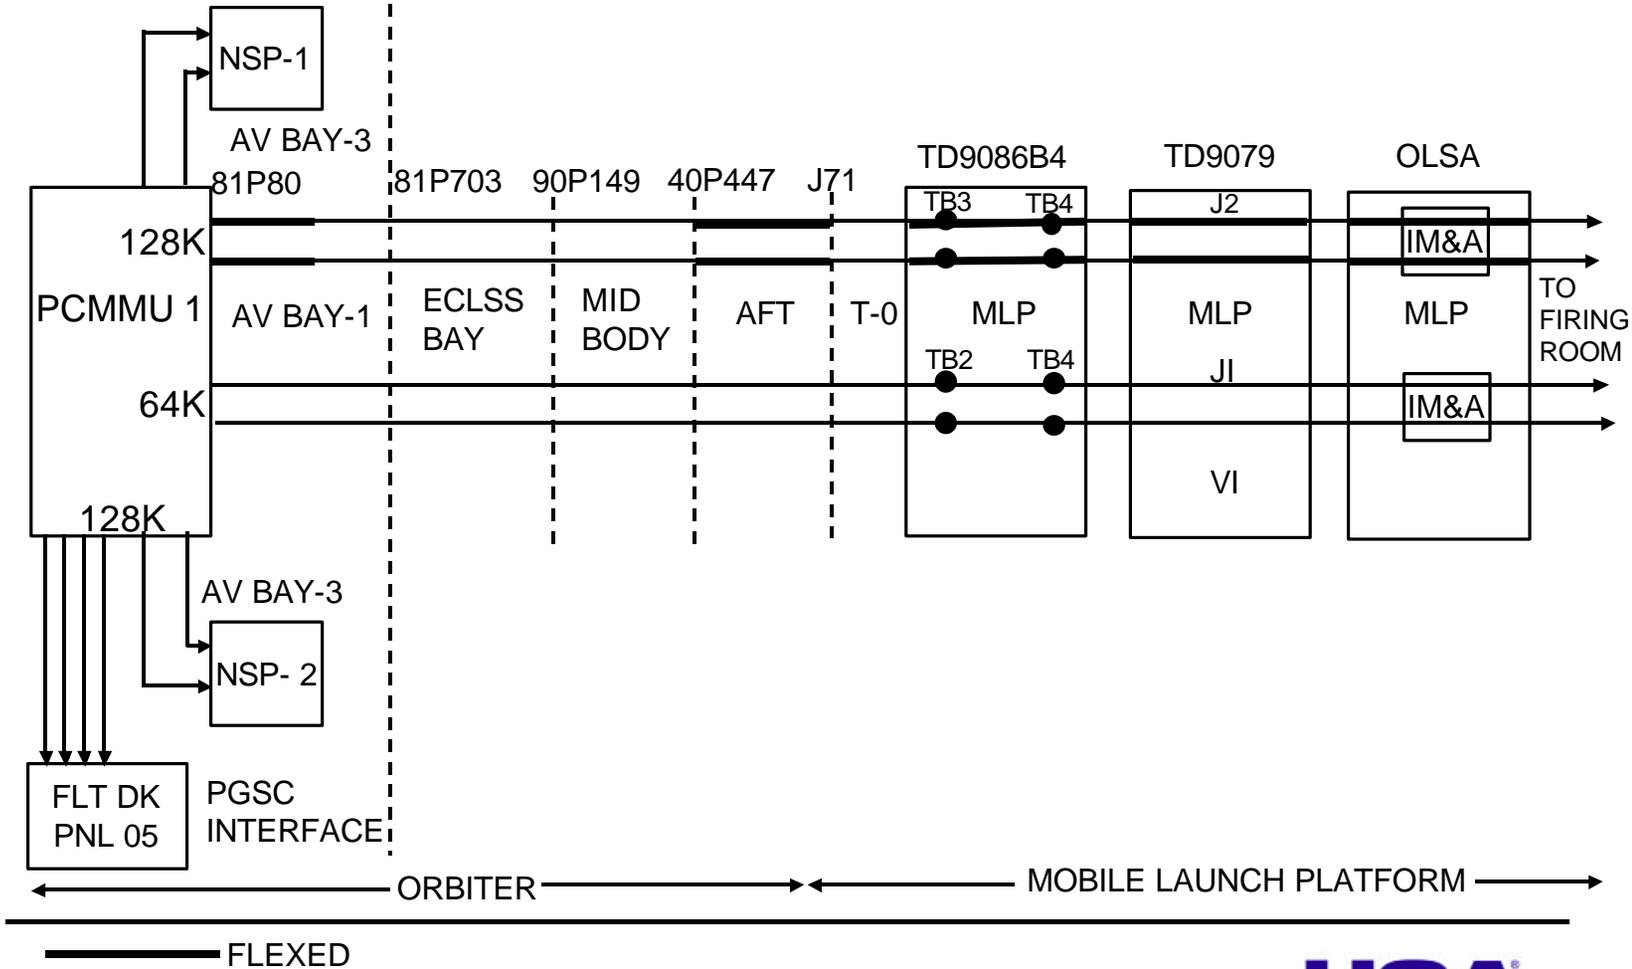
PCMMU DATA LINE ROUTING

- Observation
 - During initial Orbiter power up, after switching to Firing Room 1, signal drop outs were noted on PCMMU 1 128 kbs line to Firing Room 1
- Concerns
 - Loss of Orbiter data to Firing Room 1 during power on testing
- Discussion
 - No previous occurrence of this type failure
 - Firing Room swap does not affect signal path from PCMMU to the remote controlled video switches in the LCC
 - LCC INS-01 requires 2 of 2 PCMMU's

- Actions Taken
 - Trouble Shooting consisted of line checks from the LCC to the PCMMU 1
 - All lines and equipment from MLP Terminal Distributor Panel 9086B4 (connects to GSE T-O umbilical cable) to the Firing Room have been exonerated
 - Resistance checks done at the terminal distributor (9086B4) into the PCMMU 1
 - Open found on the Hi Side of the 128 kbs signal path
 - Connector at the PCMMU 1 was demated and inspected
 - No anomalies noted

- Actions Taken (Cont'd)
 - A Break-Out-Box (BOB) installed at the PCMMU 1 output
 - BOB fuse installed, the signal was distorted on both the high and low sides
 - Signal displayed nominal amplitude
 - With fuse removed, the PCMMU signal was nominal on both high and low sides
 - Resistance readings on the 128 kbs and 64 kbs lines down to the MLP were nominal
 - Power cycling the PCMMU 1 and flex test of wire harness
 - Aft: 1307B/H to T-0 interfaces
 - Fwd: Avionics Bay 1 to ECLSS Bay
 - Midbody and ECLSS Bay not inspected/wiggled
 - No drop out or degradation of signal in the firing room

- Actions Taken (Cont'd)
 - Additional detailed flex test/inspection of Avionics Bay 1 wire harness from PCMMU 1 to Avionics Bay sidewall
 - Performed detailed inspection and wire pull test of the backshell/connector for possible defects
 - No problems found
 - Actions Planned
 - Maximize power on time on PCMMU 1 before S0007
 - Process the IPR as a deferred UA
 - Recommend launching and flying on PCMMU 2
 - PCMMU 2 signal path has had no anomalies
 - Most Probable Cause
 - Intermittent signal path
-

- Risk Assessment
 - Very Low
 - The distorted signal was only noted in the ground OI circuit of the PCMMU 1, the Orbiter Network Signal Processor (NSP) circuits never exhibited signal distortion
 - PCMMU 2 has no failures (Installed 1/05/91)

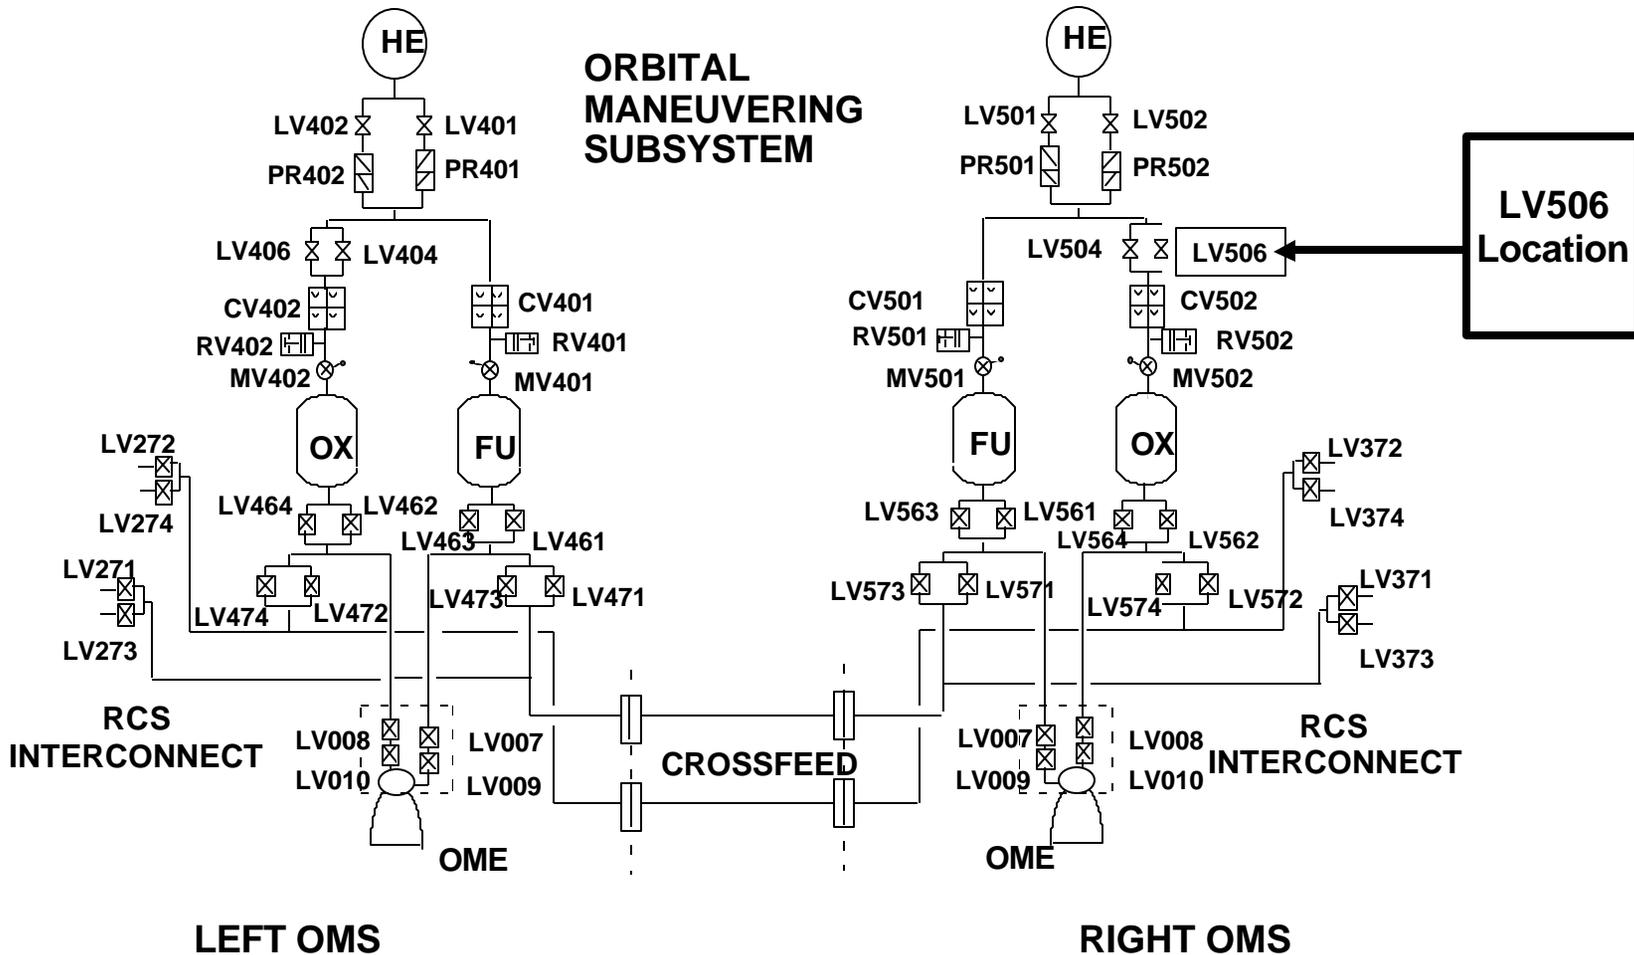
- Observation
 - During STS-102 the right OMS vapor isolation valve 2 did not indicate open for the last two OMS Engine burns (MER-16)
- Concerns
 - Valve not opening, resulting in a loss of redundant flow paths

- **Actions Taken**
 - Data review of the current draw at the time of occurrence were consistent with previous OMS burns
 - The Pod interface connector was demated and inspected and no anomalies noted
 - Break-Out-Boxes (BOBS) were installed to take reading while the valve commands was being sent, all reading were nominal
 - Wiggle test was done on electrical harness from Pod I/F to Avionics Bay 6, all indications were nominal
 - Review of SCAN showed no history of connector demate since STS-92

- **Most Probable Cause**
 - An intermittent circuit with in the VPI or solenoid circuit
